# historic structure report

## restore historic commissary building to 1897

# FORT SMITH

HISTORIC STRUCTURE REPORT  
RESTORE HISTORIC COMMISSARY BUILDING TO 1897

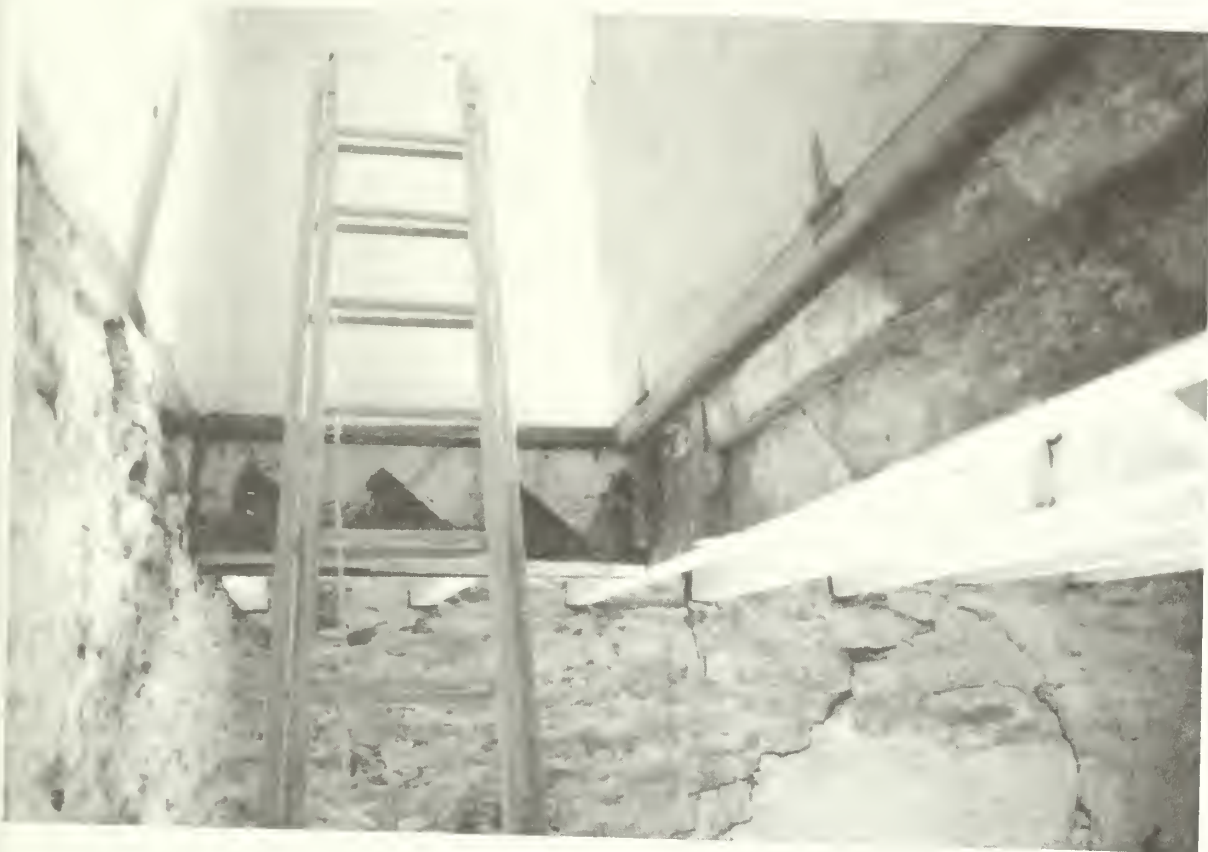
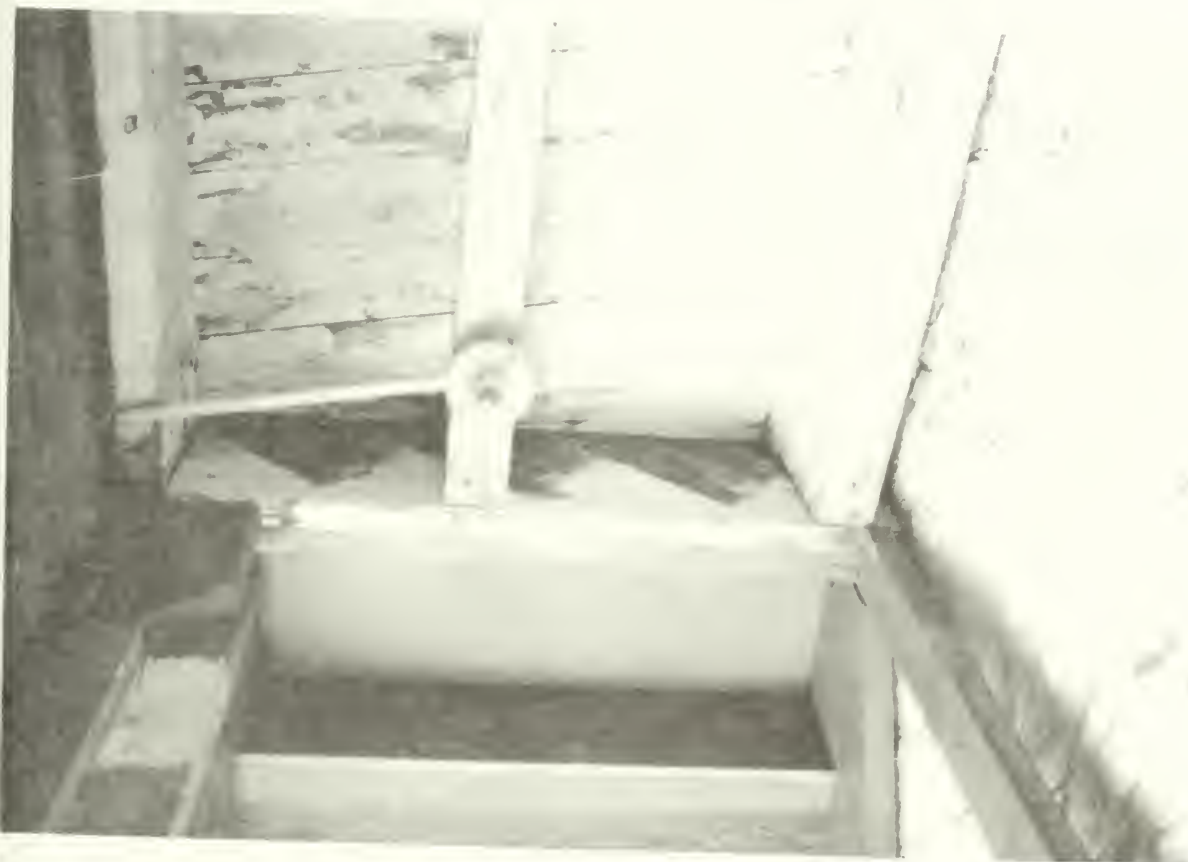
Figure 12. Header of Stair 2 (1/3/85 and 1/31/84): Fragments of a former stair stringer were used by the builder of stair 2 as the new header of the enlarged stairwell. There is no guarantee that these fragments were part of the stair 1 carriage or of some earlier commissary stair; however, they are old, rough sawn lumber with square nail holes. The effort could very well have been made to preserve fragments of a historic stair within the 1936 construction of a new one. Notice, also, ghosts of former handrails in upper photo at right--these were not covered over by the whitewash restoration and could be useful to understanding historic stairs.

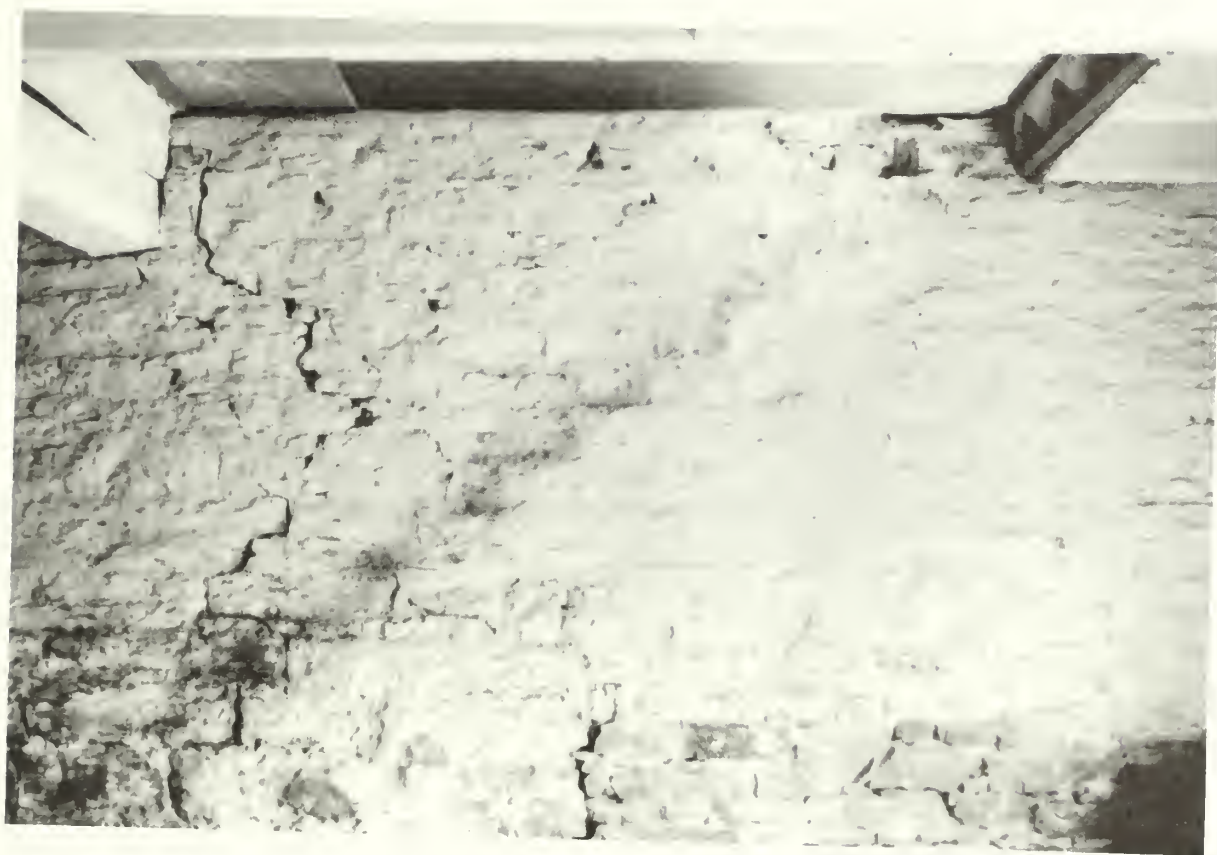
Figure 13. Stair Ghost (9/21/84): After stair 2 was removed, but prior to the repointing and crack repair on the east wall, the ghost of stair 2 was very distinct. Evidence of earlier stairs was less distinct but still visible.

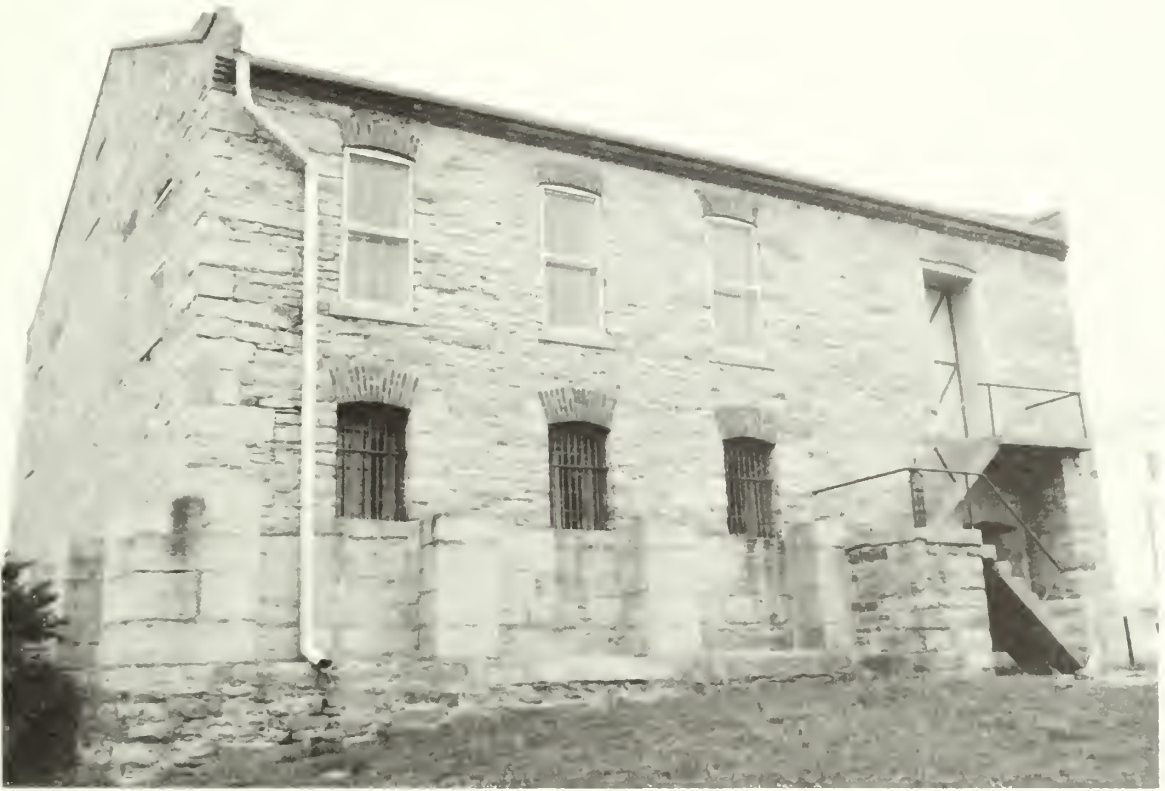
Figure 57. Southwest Exterior View (5/18/82): This view shows the painted metal downspout that was replaced in 1983 and the condition of stone masonry mortar joints that were thoroughly repointed in 1984.

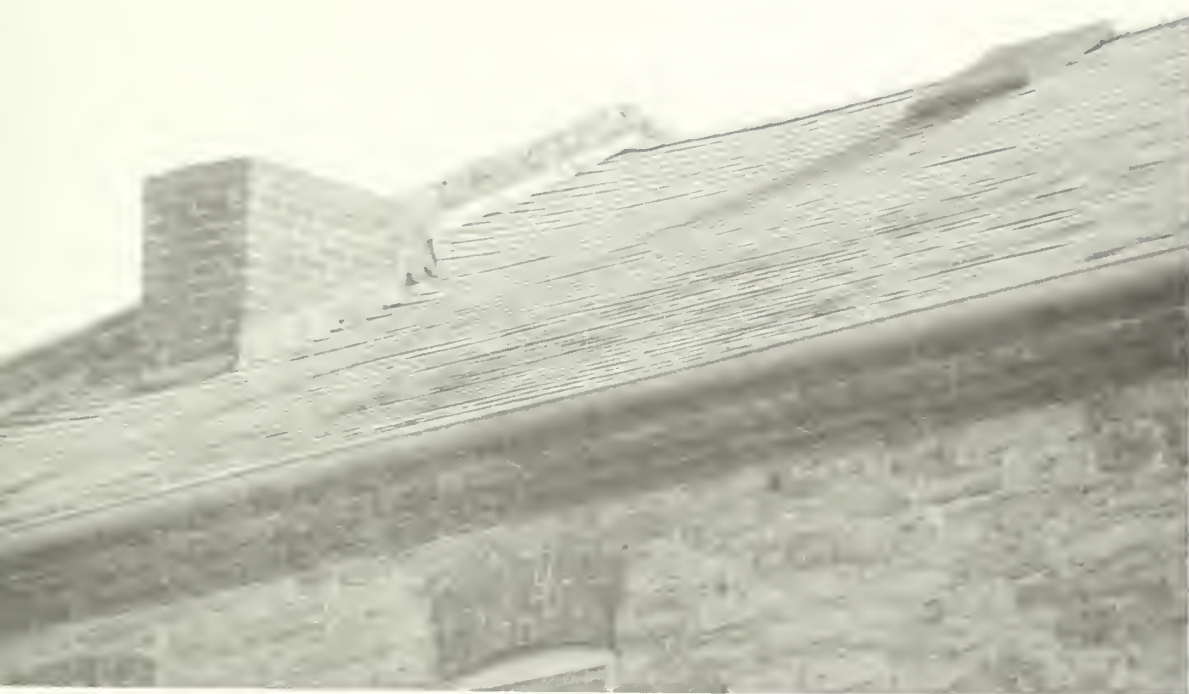
Figure 59. Roof Features (5/20/82): This detail documents the condition of asbestos shingles, galvanized steel flashing, and the roof scuttle cover that was removed in the fall of 1983. Note, too, the west chimney as it looked before 1983 when it was restored to its ca. 1897 height. The restoration was based on the number of brick courses and design detailing in figures 31 and 33.

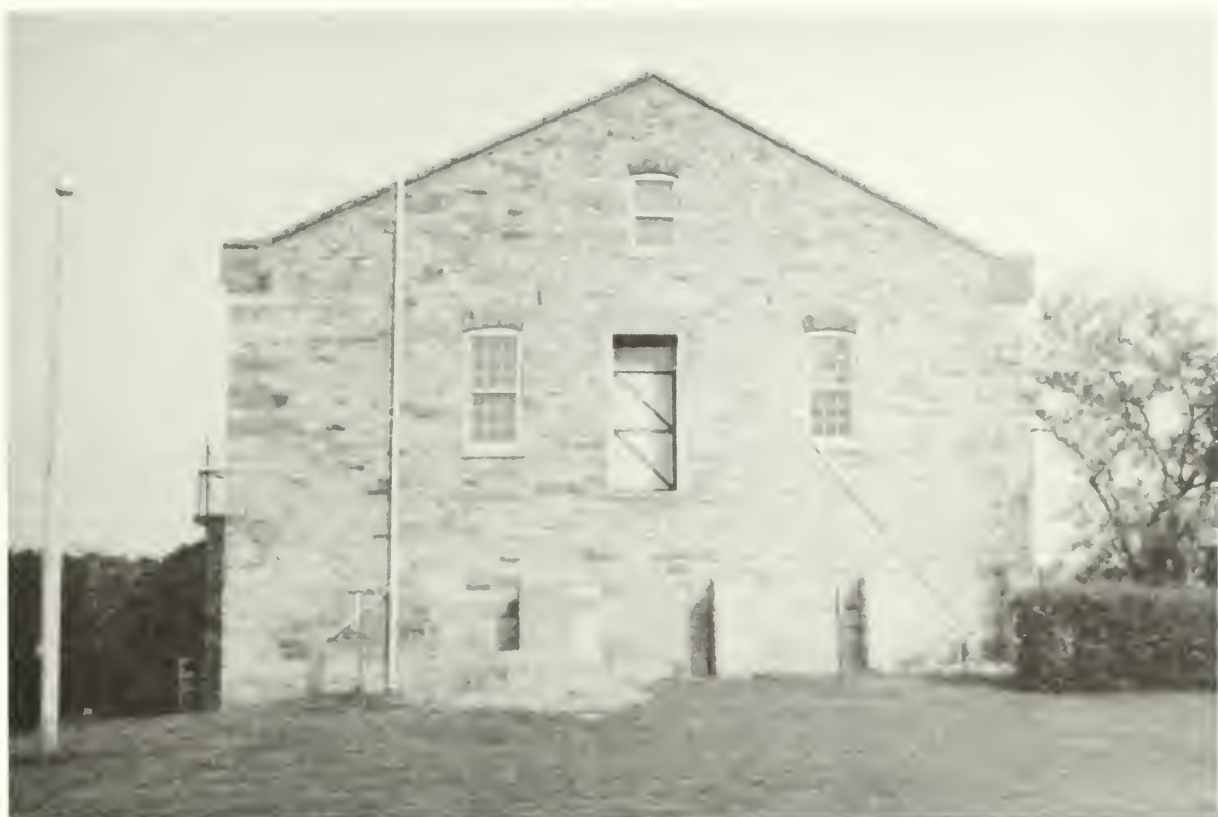
Figure 61. East Corner Detail (10/8/83): The intrusive electrical and telephone entry equipment shown here were removed in 1984, and service entered underground below floor level.

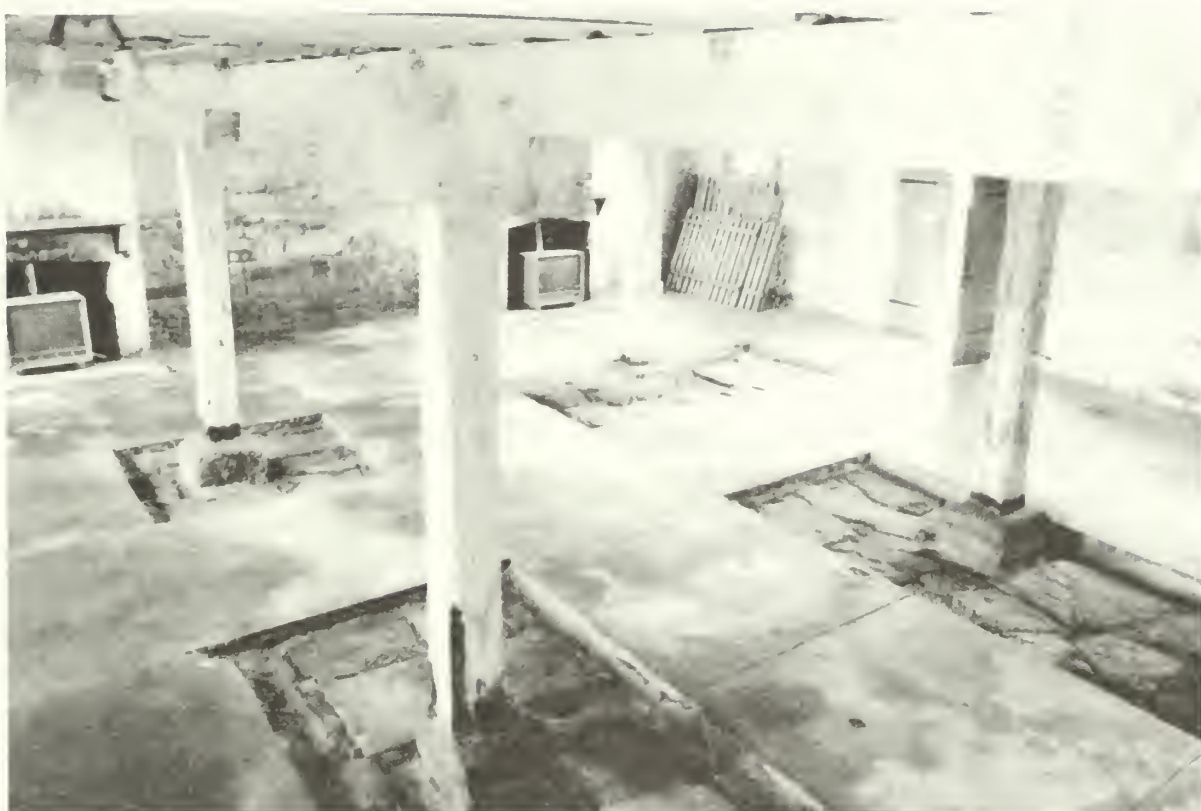
Figure 63. First Floor (6/26/83): General view of first-floor condition before restoration. Note light fixtures, gas stove heaters, and concrete slab floor that were removed, and deteriorated support posts and whitewash that were restored.

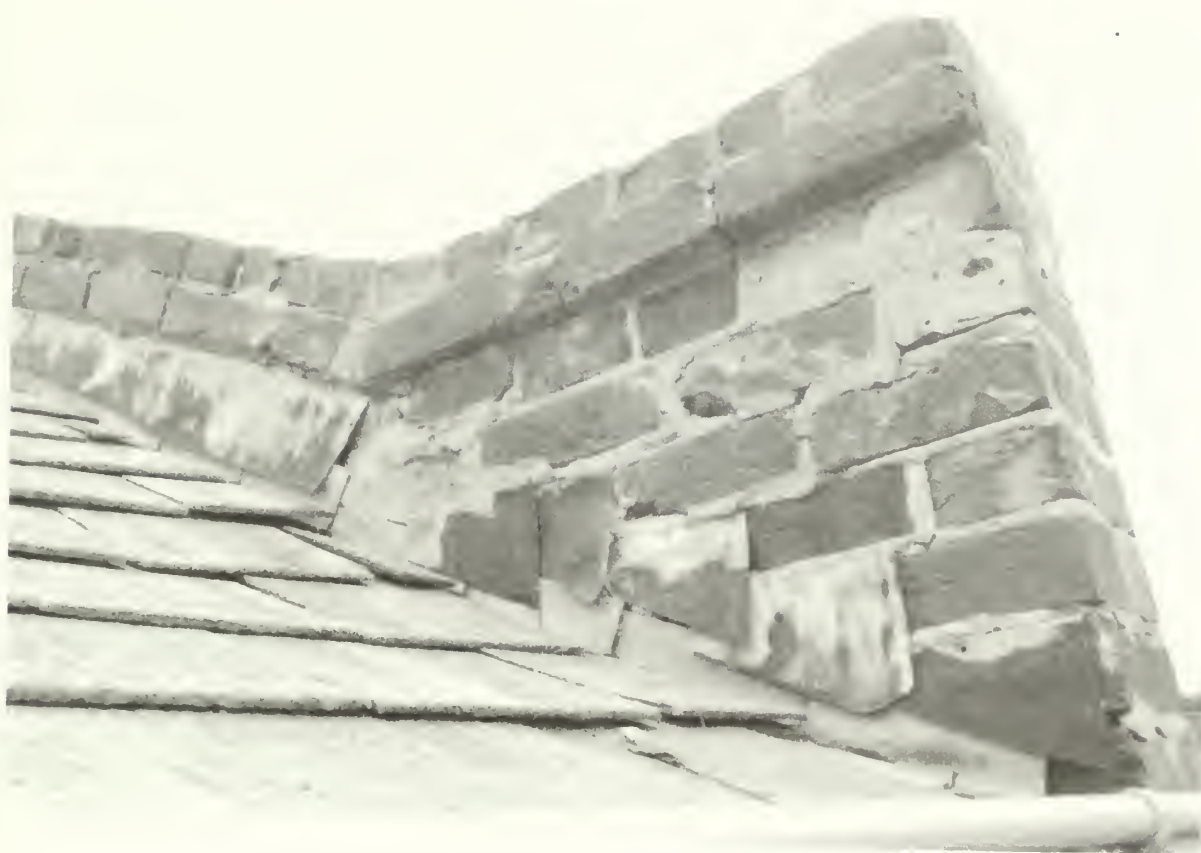
Figure 67. South Brick Cornice (6/25/83): It was recognized that the brick cornice had suffered deformation because of wall and door arch settlement, and cracks and some repointing was anticipated. The extent of the condition, however, was revealed only after the gutters and roof eave were removed (see figure 68).

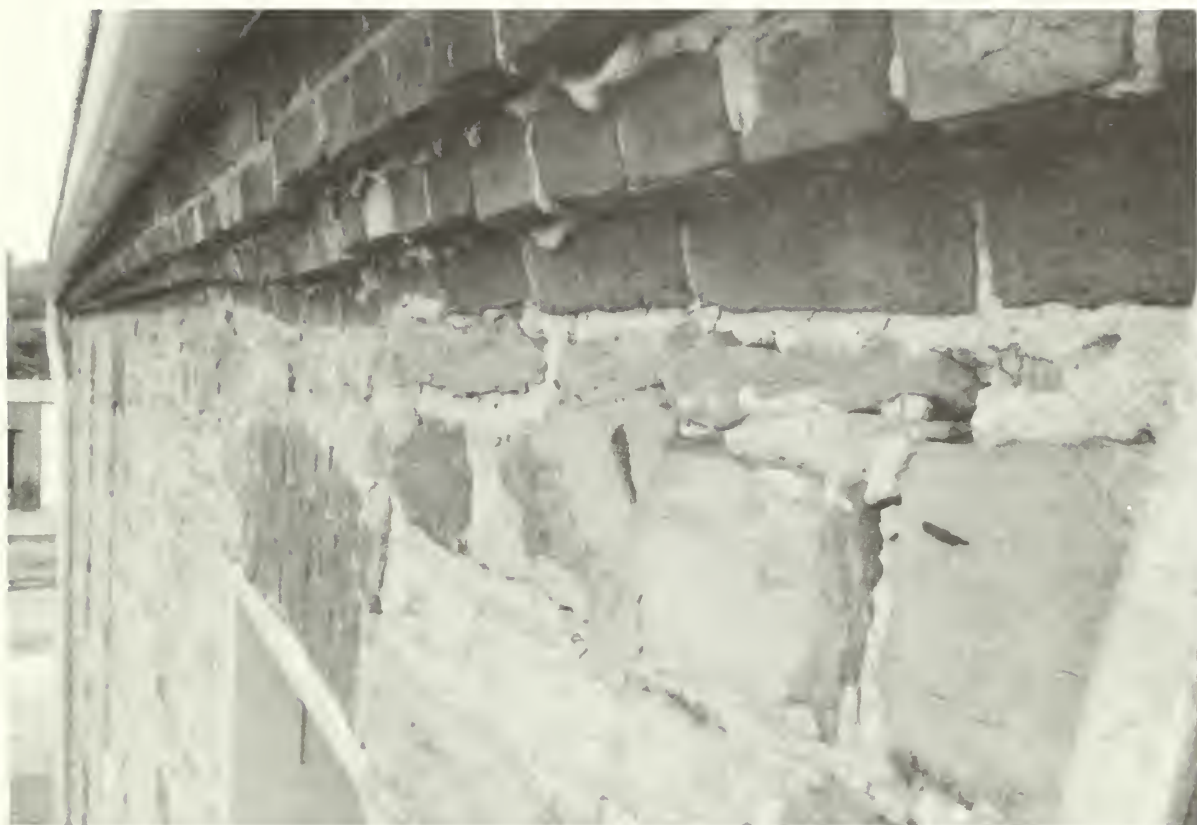
Figure 68. South Brick Cornice (10/7/83): After the gutter and roofing was removed, it was clear that the cornice at the south eave was separating and the danger of its falling off was apparent. The separation was nearly two inches. It was decided to dismantle the brickwork to a sound level and rebuild the cornice, duplicating the original profile, and using metal brick ties to secure it to the brick nogging between the attic joists.

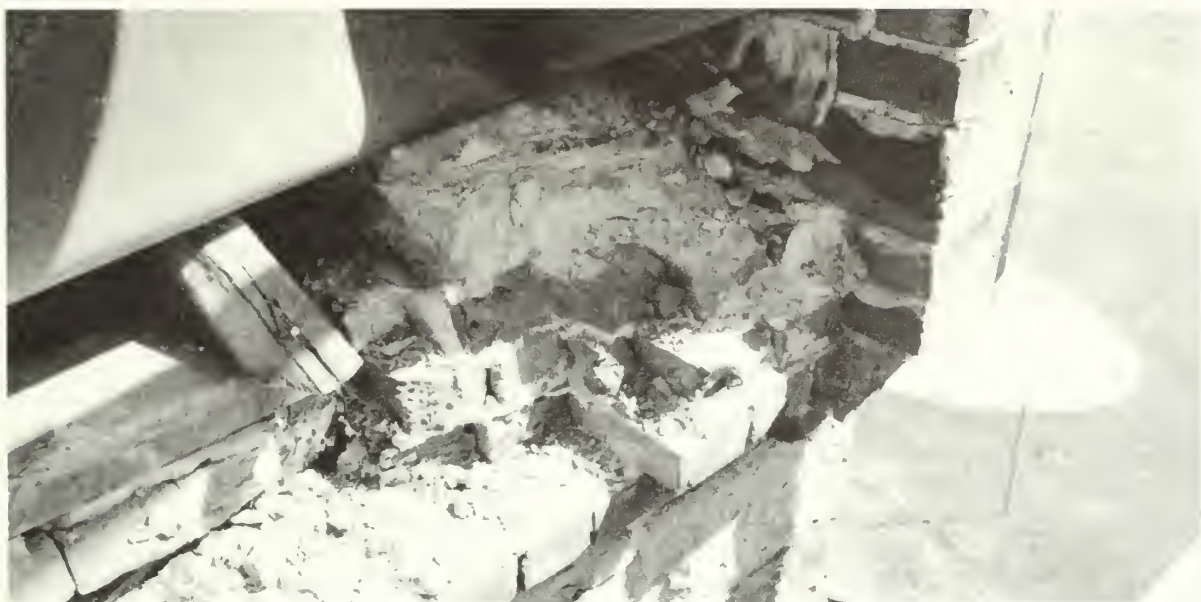
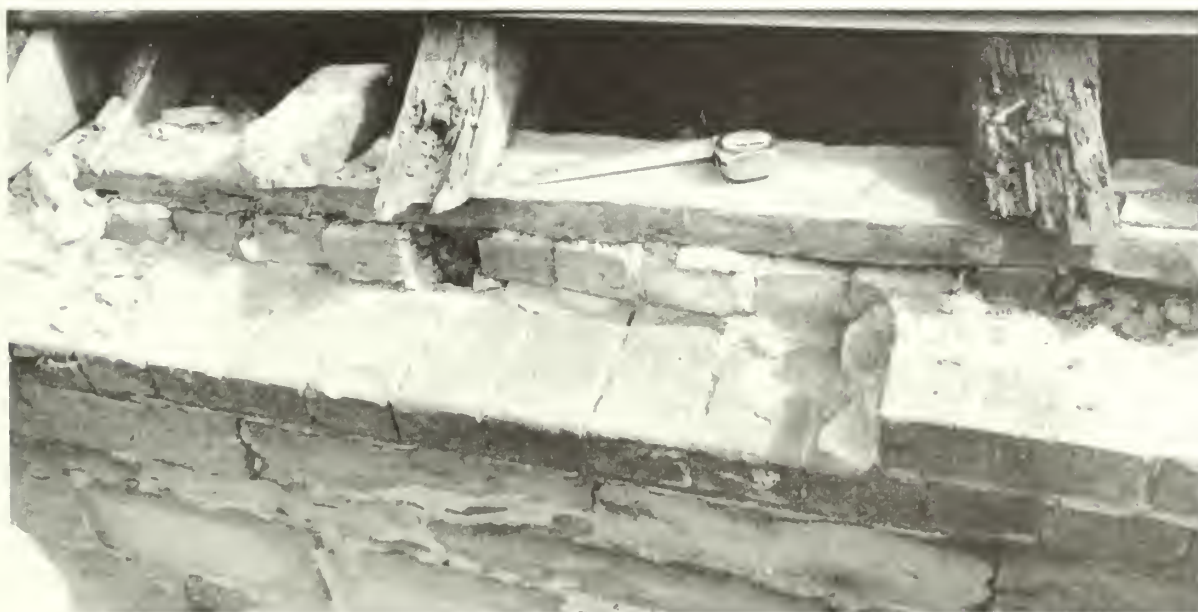
Figure 69. South Brick Cornice (10/8/83): The brick dismantled effortlessly because the lime mortar had become quite useless. Rafter tails too, were exposed to inspection, and although somewhat weathered, their condition was generally very good for their 140-year age. In some cases, sister rafters were nailed to the existing to reinforce them as had been done traditionally - note left rafter in lower photo.

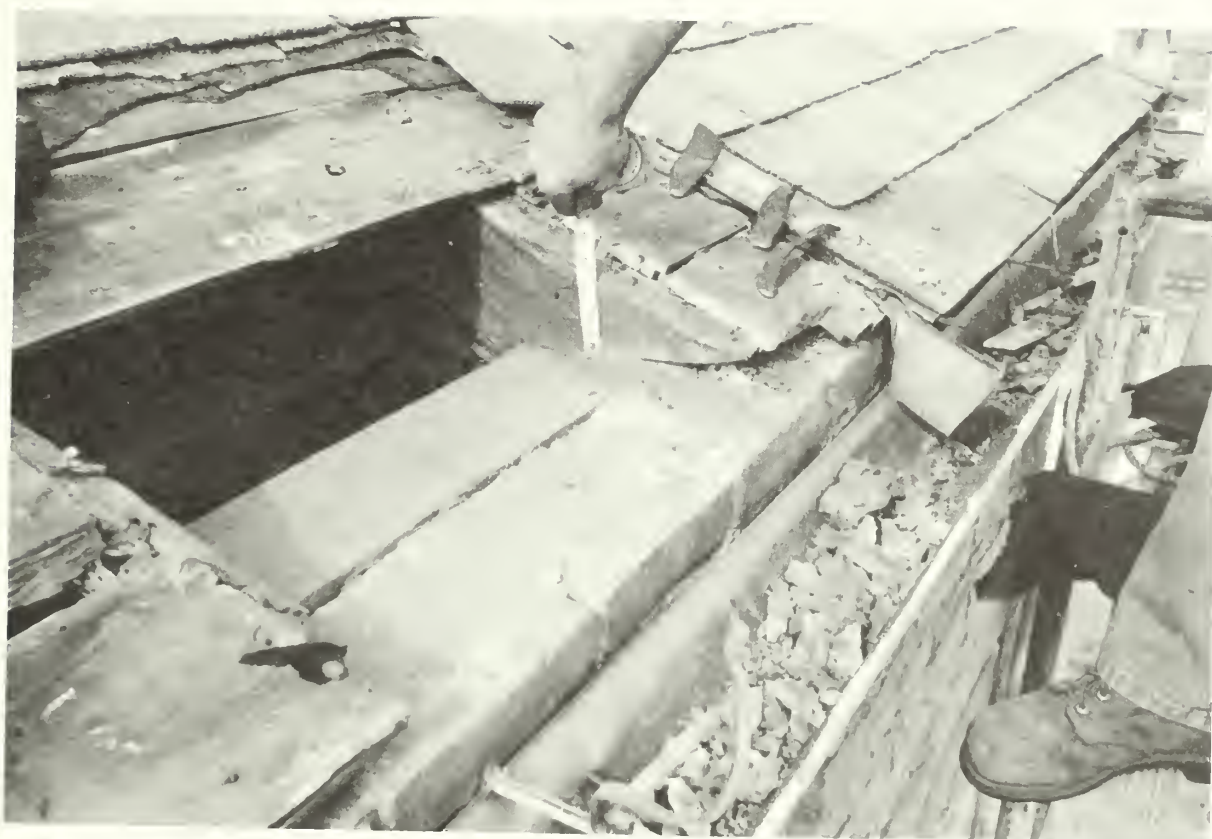
Figure 70. North Eave (10/7/85): At the north, brick cornice separation and deterioration was much less than the south: no wall or arch cracking was present. Subsequently, very little brick repair was undertaken on the north.

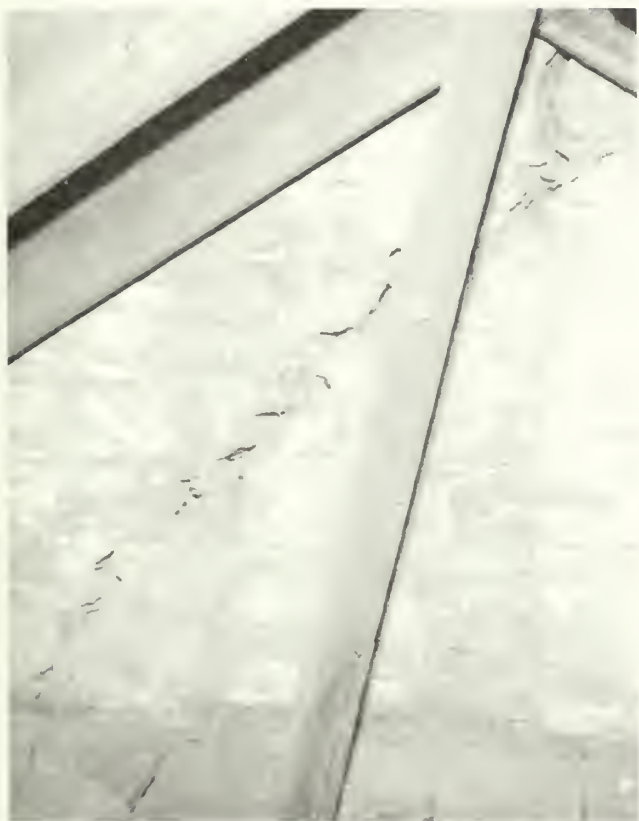
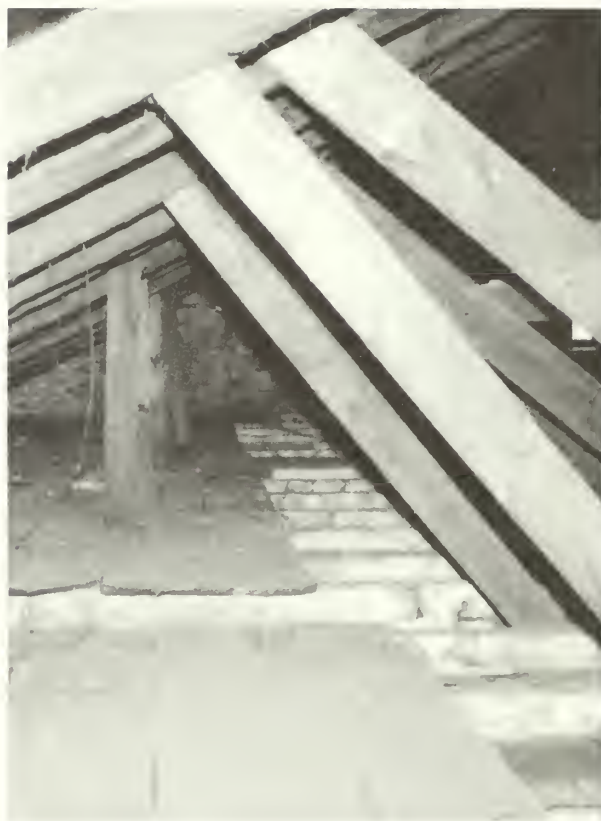
Figure 76. Attic (6/25/83): Four points are illustrated in these photographs. At the left, the large east wall shear crack is clearly visible, but more importantly, it is an old and dormant crack whitewashed historically. In the right view, the attic floor joists appear with a whitewash coating showing that the second floor had a semiopen ceiling between 1845-1866 and was whitewashed before being plastered in 1866. The variety of modern rafter bracing is shown and the need to replace it with a uniform and reliable system is apparent. The network of dead vines suggested that the growth of vines (see historical photos) was very extensive and probably caused damage to the roof system.

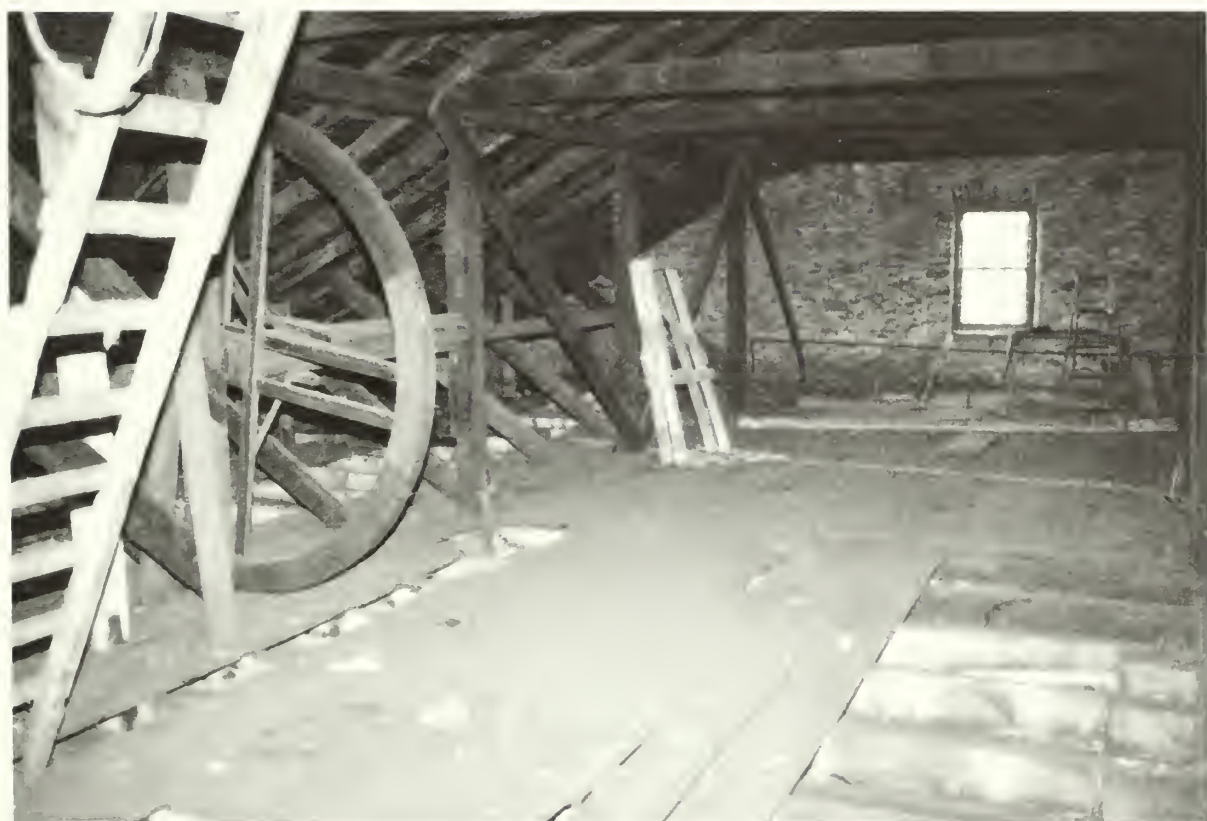
Figure 77. Attic (5/20/82): General view showing condition before phase I work. The planking was taken up, the entire attic floor insulated, and then the planking reinstalled.

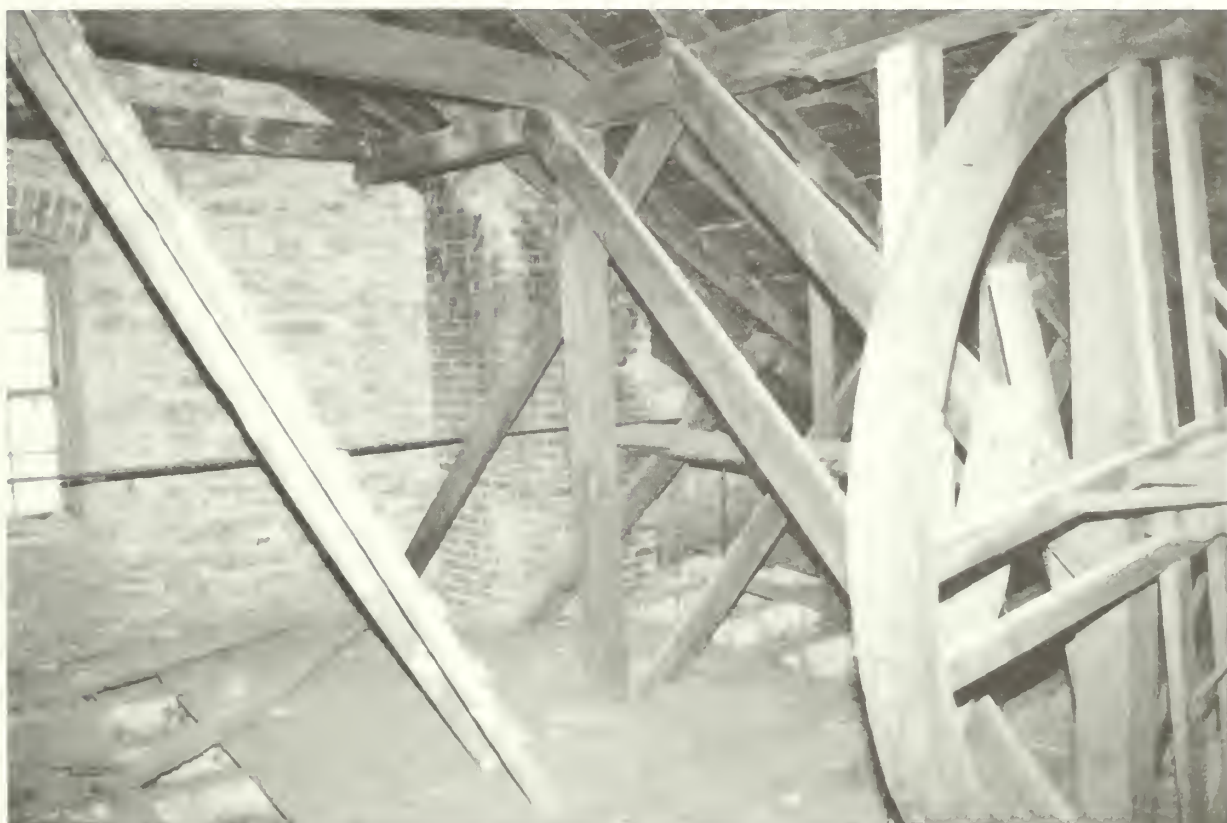
Figure 78. Attic (5/20/82): There were several features of the attic that required treating in the phase I work: the chimneys were stained and discolored because of roof leakage, and the brick mortar joints were eroded - daylight was visible through many joints; the hybrid system of rafter bracing was, by engineering standards, unreliable; and the hoist was dried out and needed wood preservation. Note, also, scatter of slate shingles on floor and missing floorboards.

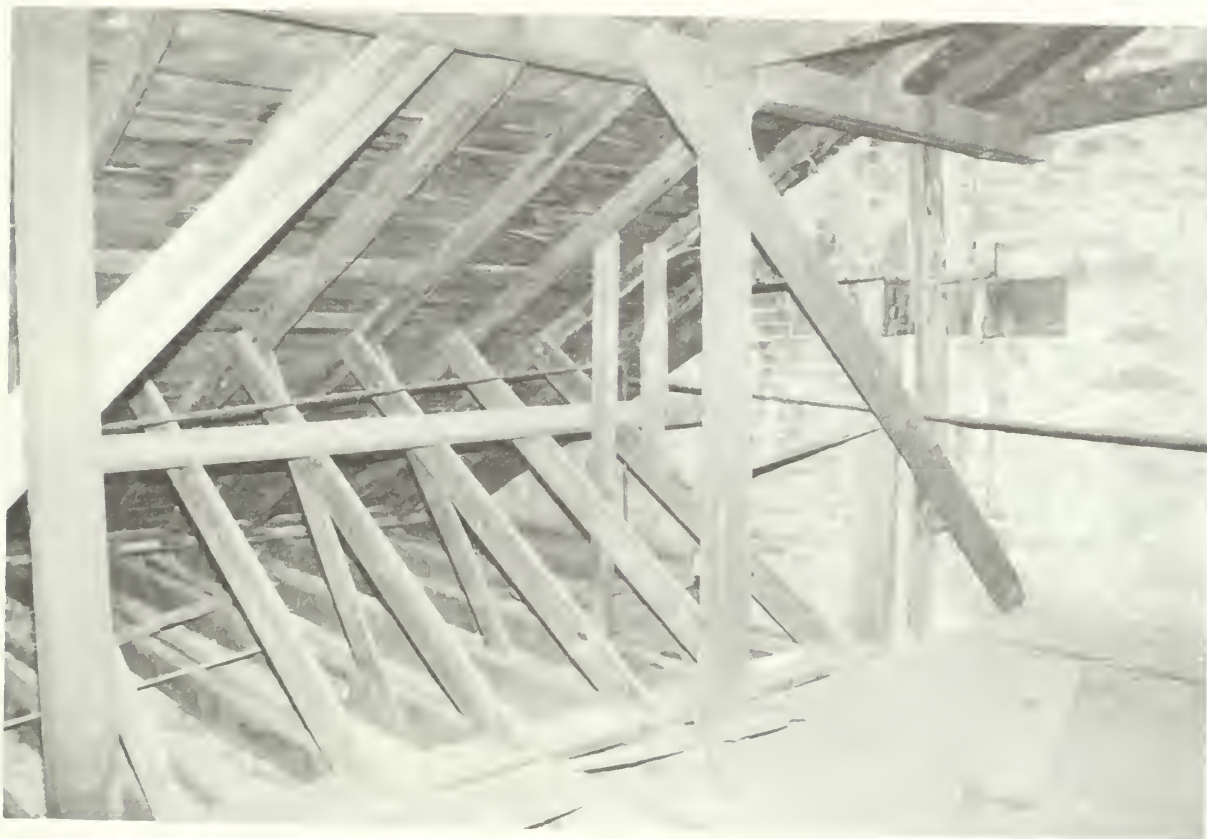
Figure 79. Attic at Southwest Chimney (6/25/83): The discoloration on the chimney brick, as well as the complexity of bracing and repairs, provided evidence of recurring problems in this area. Not only was rafter bracing replaced, but post-to-post cross-bracing and purlins also had to be replaced as part of the chimney stabilization. The chimney, itself, was dismantled down to floor level and rebuilt with the same and duplicate brick with lime-cement mortar in 1983.

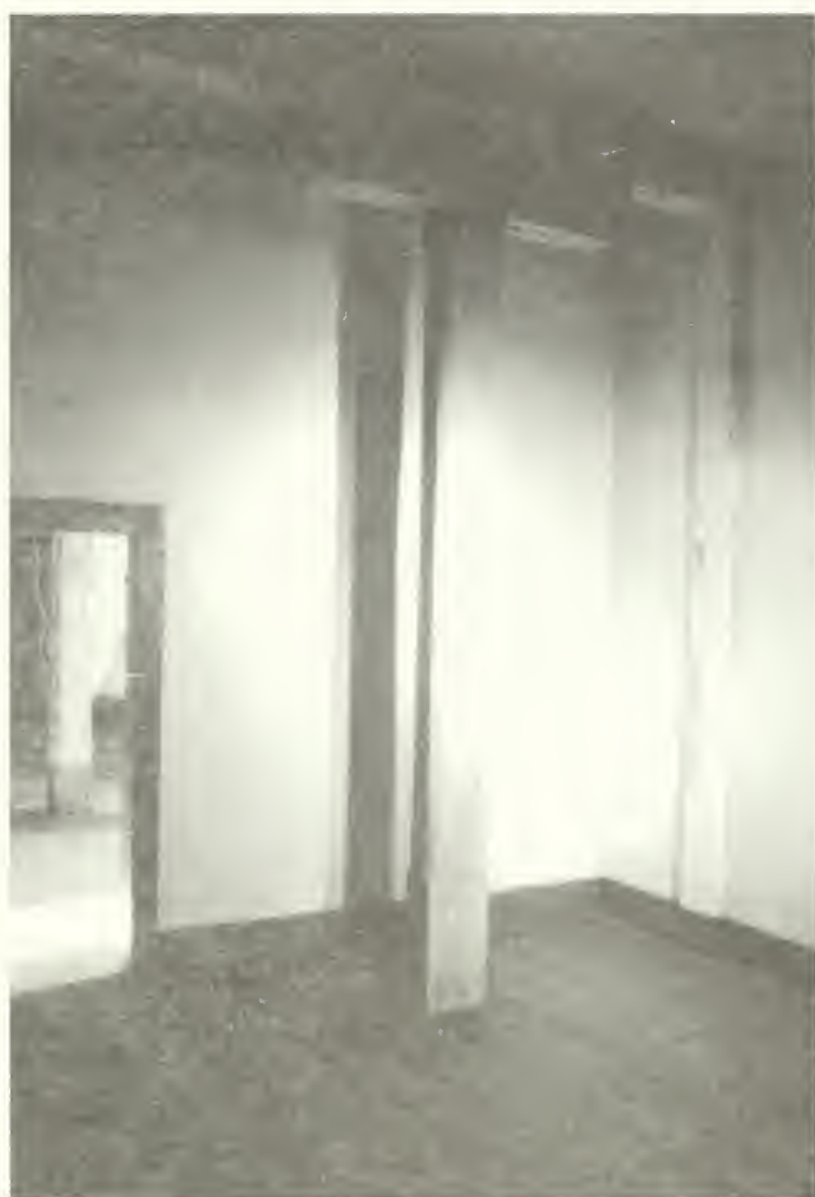
Figure 84. Reconstructed Support Post (12/14/83): The original support post at this location was removed, maybe as early as 1866; but, at least by the time the present partitions were installed. The 3" by 8" pilaster to the right was installed to replace the post function, an inadequate structural solution. The new post here duplicates size and design of posts in the north room and is hewn red oak.

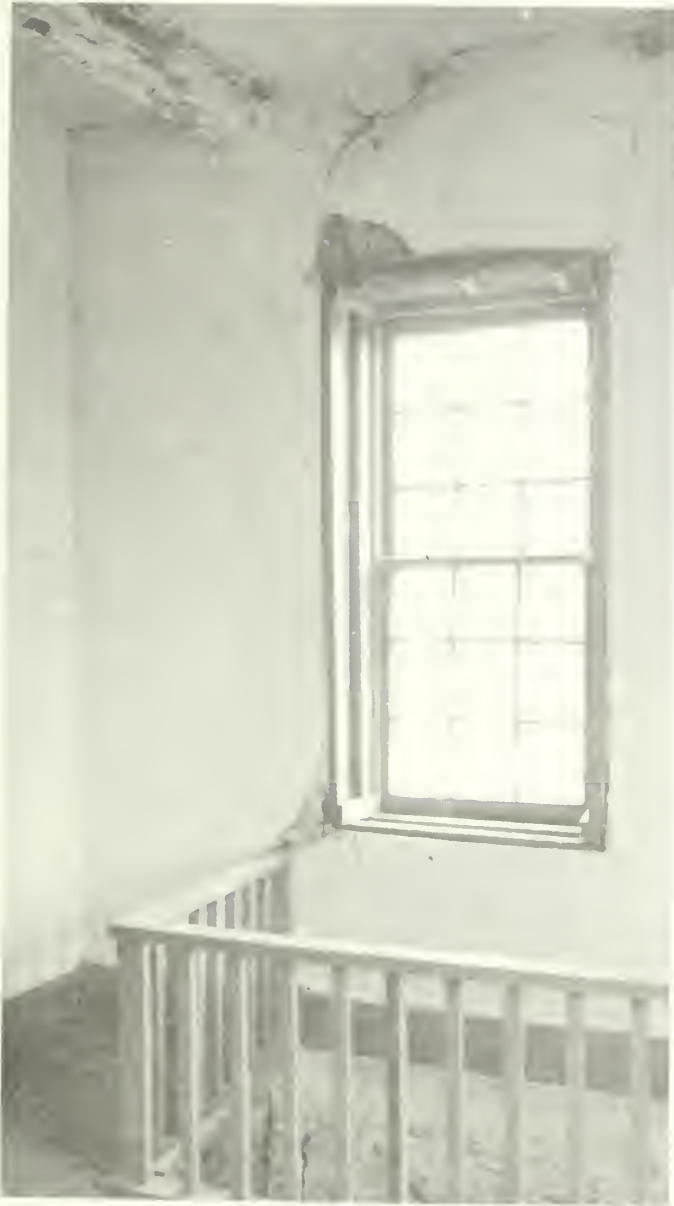
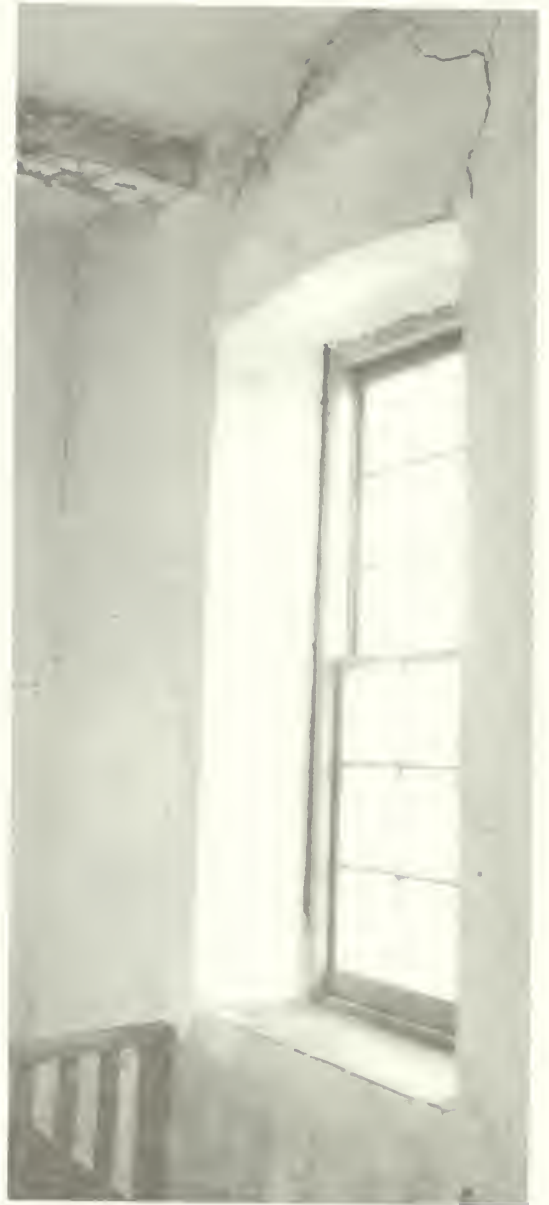
Figure 94. Southeast Window - Second Floor: Views show window opening with wood bracing and deterioration (6/25/83) and after masonry stabilization (1/3/85). The rowlock brick arch on the exterior of this window was taken down and reconstructed.
